PLASTIC BIOCARRIERS

POLLUTION OF BEACHES AND WATERWAYS BY BIOMEDIA, PLASTIC CARRIERS FOR BACTERIAL PROLIFERATION USED IN WASTEWATER TREATMENT

2ND EDITION - DECEMBER 2023

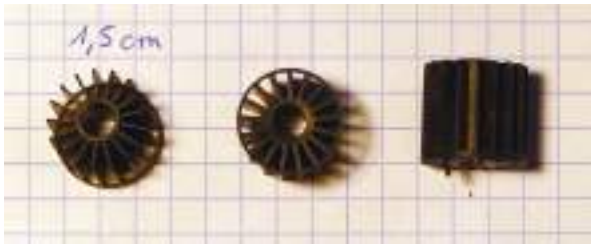
OBSERVATIONS
In December 2022, following minor flooding, high amounts of biomedia were found on the banks of

the river Gervanne downstream from the Font Rome fish farm. A hiker counted up to 50 per square meter, a sign of close and recent pollution.

DESCRIPTION OF THE INCIDENT:
We were given only limited information regarding the specific causes of the incident. According to the information we did receive, the fish farm's wastewater treatment station did not comply with norms and declarations were not made after the facilities were expanded.
